Site Remediation: „Getting Our Act Right“

A Case History

*IV. International Seminar on Remediation of
Contaminated Sites*

Merial Paulinia Site:

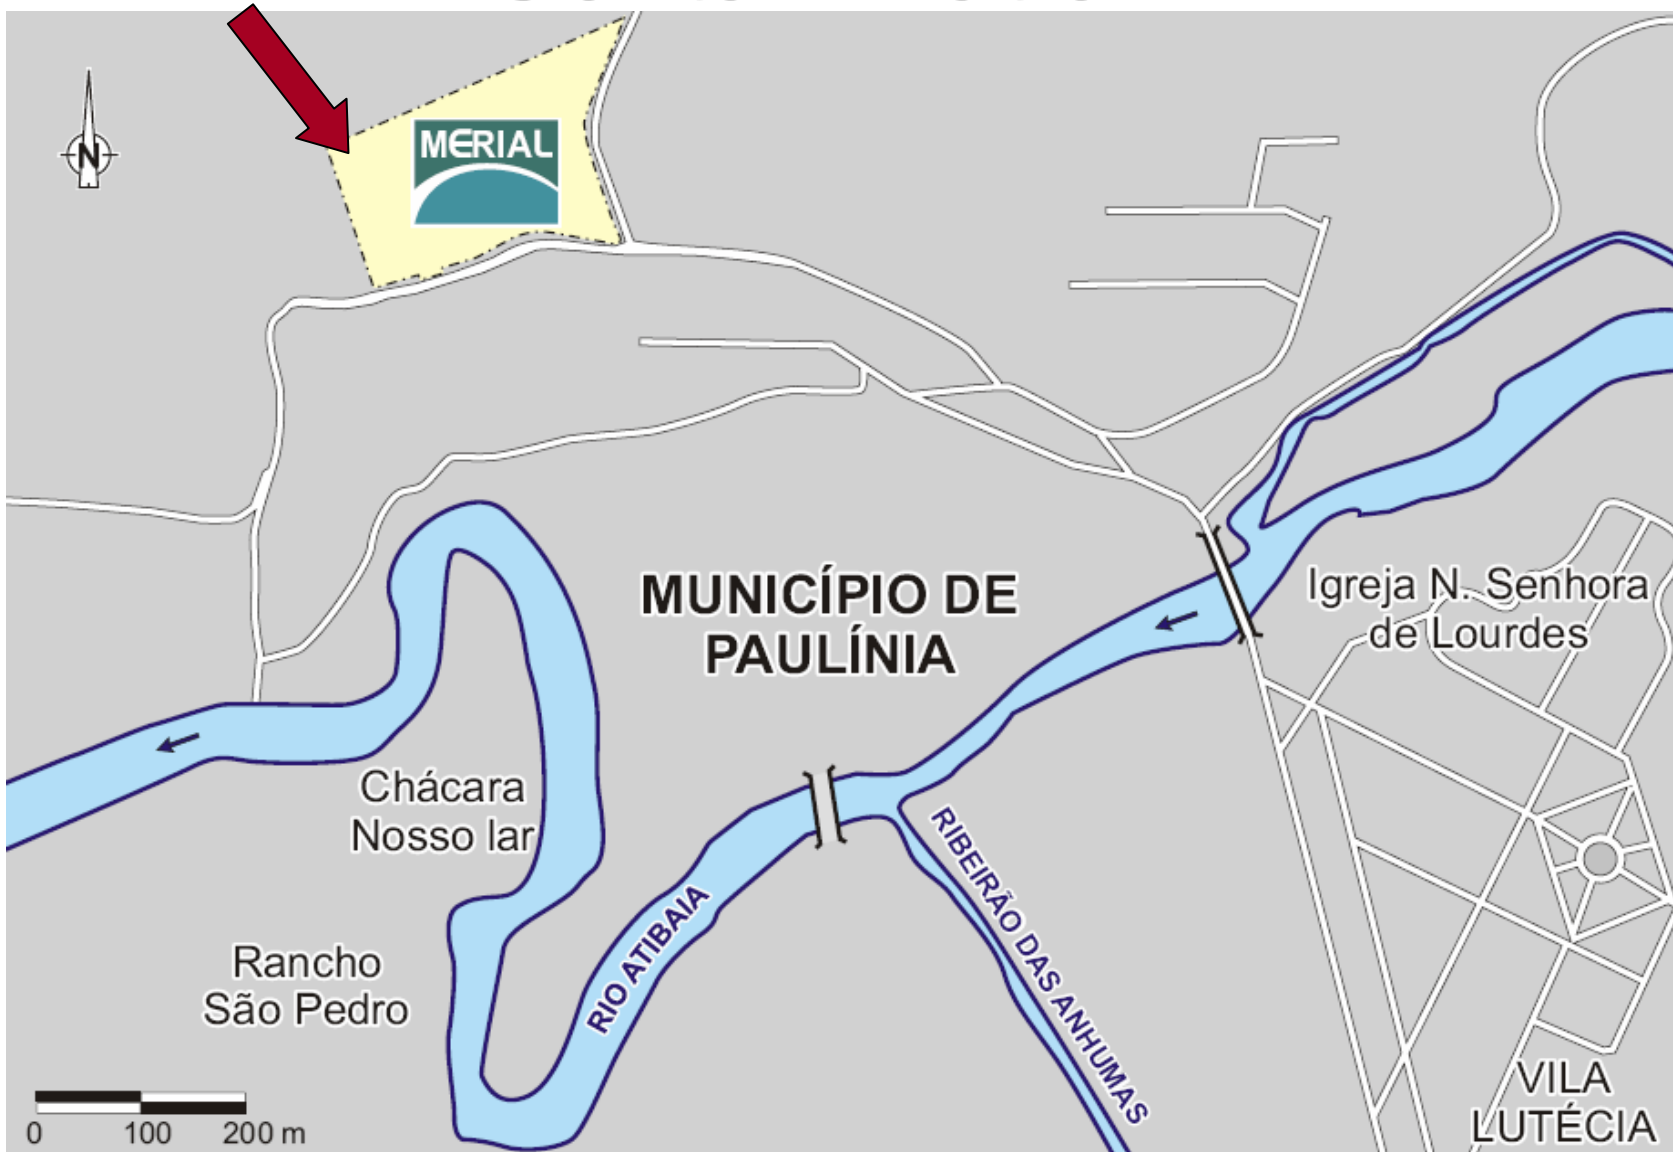
Case History: Location of Contamination

- Traces of **chlorinated solvents** found in ground water during a “due diligence” process
- **Buried drums** identified as source of pollution (no historical records found)
- Corporate decision to **inform** openly and to perform a **state-of-the-art** clean-up operation

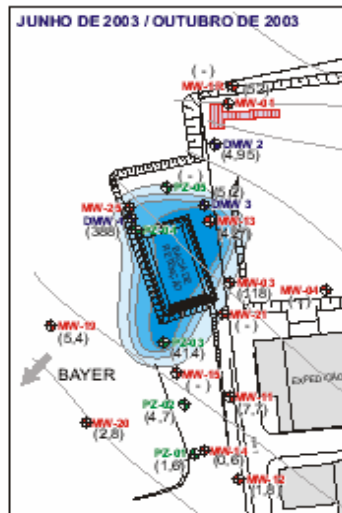
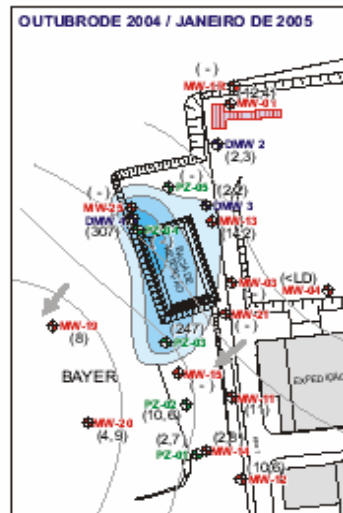
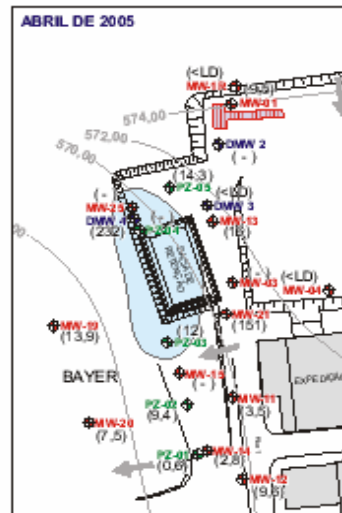
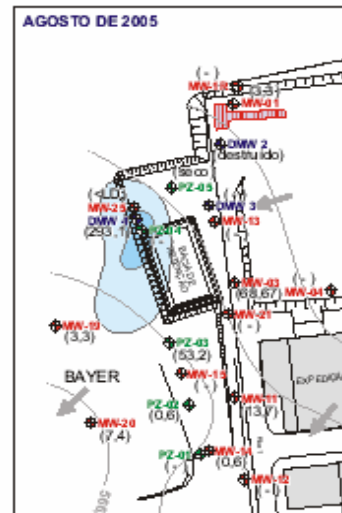
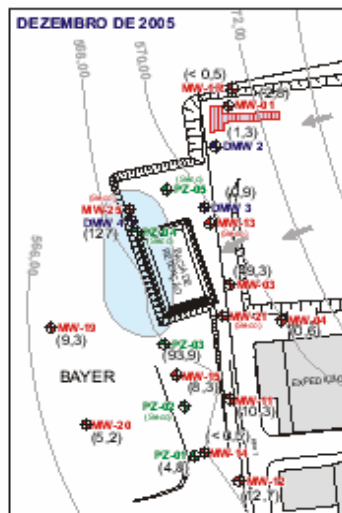
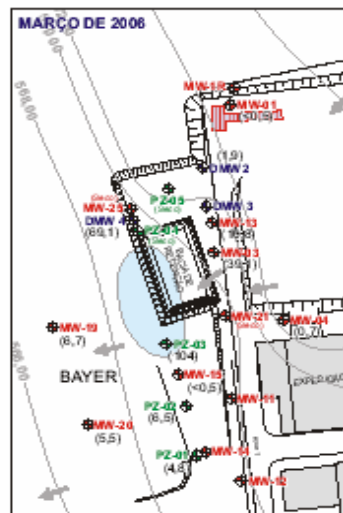
Natural Attenuation Chloroform (CHCl₃)

CONCENTRAÇÕES DE CLOROFORMO (µg/L)

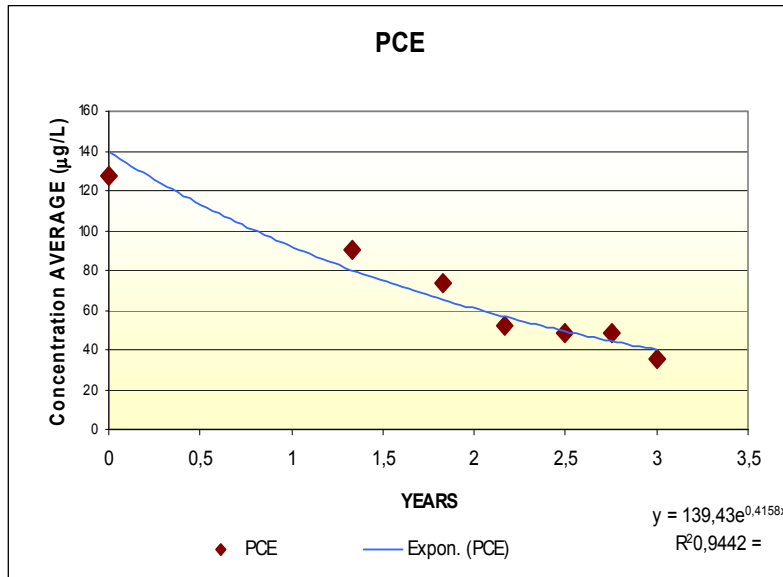
Natural Attenuation – Half-lives of relevant compounds

$T_{1/2}(\text{PCE}): 1,7 \text{ YEARS}$

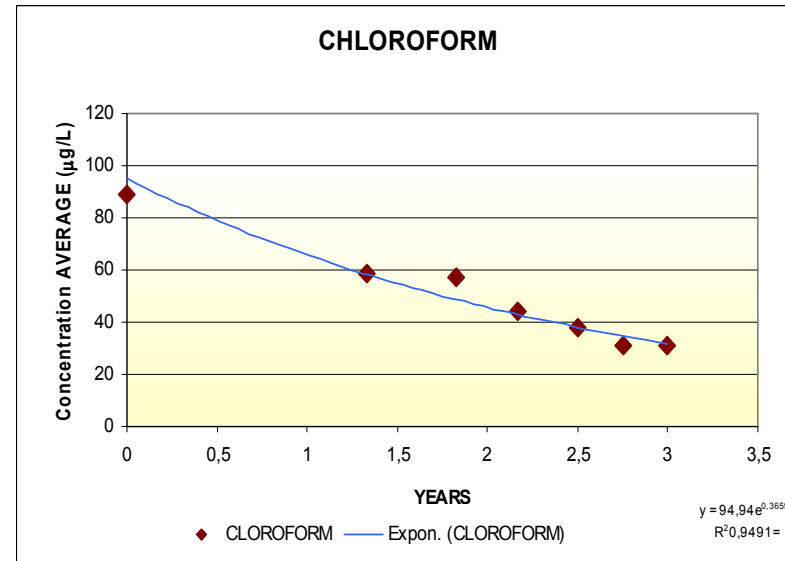
$T_{1/2}(\text{chloroform}): 1,9 \text{ YEARS}$
