Site Investigation, Sustainable Remediation & Ecological Restoration of a Century Old Former Zinc Smelter Site

Mark A. Travers, J. Mark Nielsen, and Ralf Lattouf

ENVIRON International Corporation

October 2010

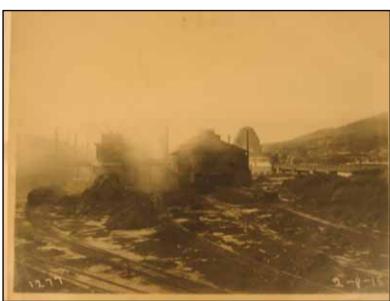
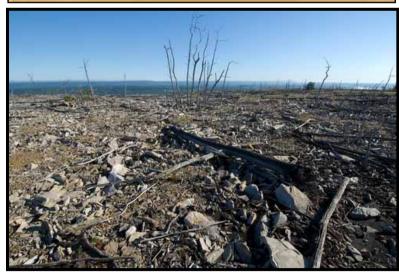
Former Zinc Smelter Site

- Two zinc smelters in one town -East and West Plants
- Plants began operating in 1898
- Produced over 33 million tons of slag – placed in a pile over 2.5 miles long
- Air emissions resulted in deforestation (~2,000 acres)
- High levels of arsenic, cadmium, copper, lead, and zinc found in surrounding area
 - Soil impacts over several thousand acres
 - Indoor dust
 - River sediments

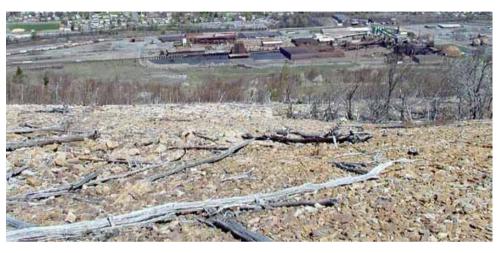
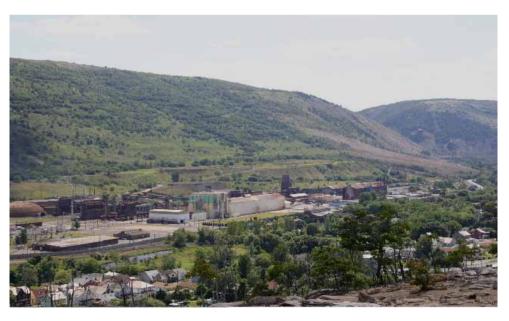
Regional Restoration

- In 1987, remedy for addressing the denuded mountain was proposed
 - spreading soil amendments
 - seeding with grasses and tree seedlings

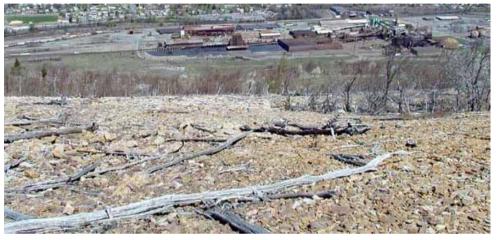
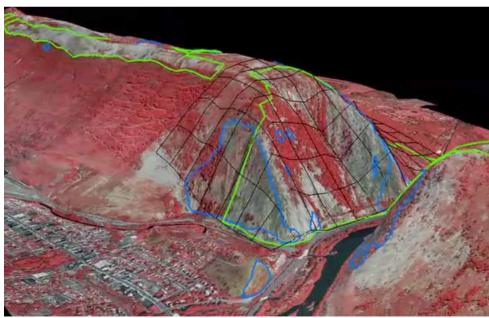
Regional Restoration

- In 1987, remedy for addressing the denuded mountain was proposed
 - spreading soil amendments
 - seeding with grasses and tree seedlings.
- Efforts to revegetate remaining areas are ongoing
 - Stabilize remaining areas where vegetation has not yet been restored
 - Tree planting

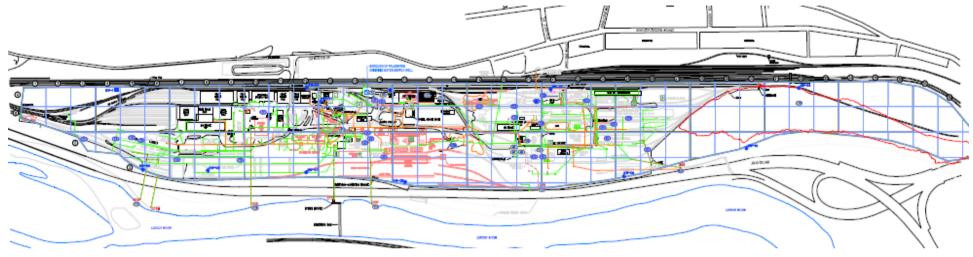
West Plant – Characterization

- Map site conditions including several generations of process operations
- Field screen methods (e.g. XRF) to rapidly characterize sitewide fill and suspected source area
- Focused soil and groundwater sampling based on field screening
- Perimeter air sampling

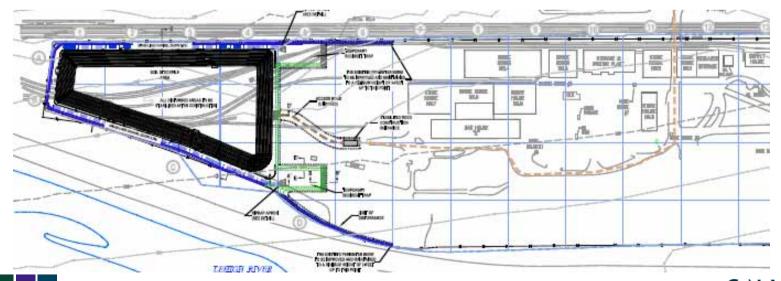
West Plant – Remediation

- Utilize risk assessment and redevelopment plan as basis for site remedy
 - Direct Contact: Buildings, pavement and construction fill serve to prevent contact with contaminated soils
 - Vapor Intrusion: Building layout and design to mitigate potential vapor intrusion exposures
 - Off-site Migration: Stormwater management devices installed for remediation will be maintained for site redevelopment
- Provide for groundwater monitoring & institutional controls

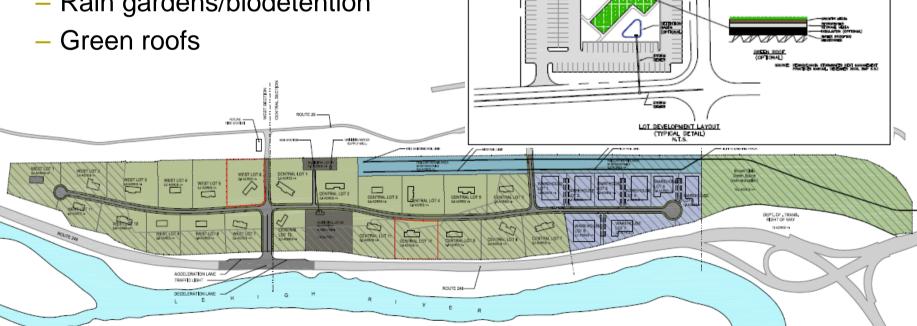
West Plant – Redevelopment

- Mixed use
 - Commercial
 - Warehousing
 - Dedicated green space
- Incorporate green design
 - Porous pavement
 - Rain gardens/biodetention

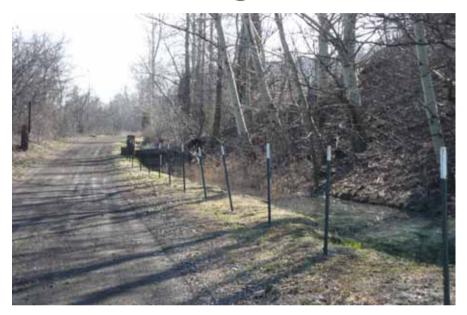
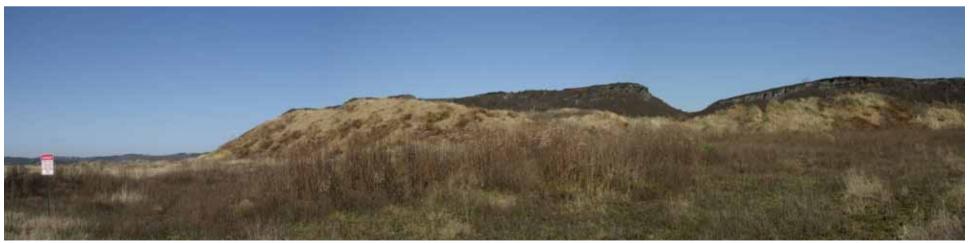
East Plant – Cinder Bank Management

- Metals are continuing to leach from the cinder bank
 - Rainfall infiltration
 - Surface water run-on & infiltration
- Continued loading to adjacent river from groundwater
